Surgical Removal of The Mechanical Valve Leaflet Dislocated into The Pulmonary Vein

DOI: 10.21470/1678-9741-2021-0350

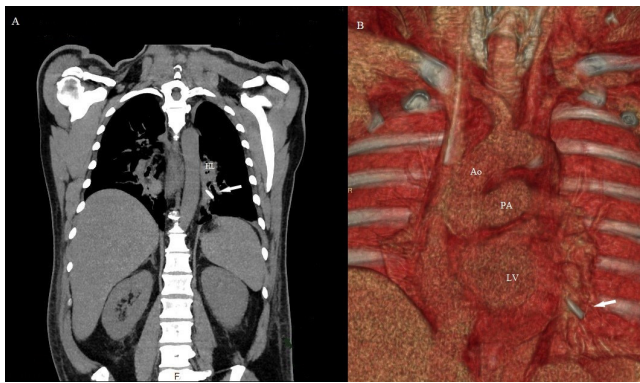
Fig. 1 - CT scan revealed a mechanical aortic valve hemidisc into the inferior left pulmonary vein. (A) Native computed tomography scan. (B) 3D volume rendering reconstruction of the chest. White arrow=artificial valve hemidisc. Ao=aorta; HL=hilum of the lung; LV=left ventricle; PA=pulmonary artery

performed, and the missing leaflet was visualized about 2.5 cm deep into the left inferior pulmonary vein (Figures 1A and B). The patient was immediately transferred to the operating room. Reoperation was performed through median sternotomy using standard cardiopulmonary bypass. The aorta was clamped, and the heart was arrested with blood cardioplegia. Two deep stay stitches were placed on the left side of the pericardium to lift the heart into a good position and satisfactory visualization of left pulmonary veins and atrium. A 1.5 cm longitudinal incision was made just before the bifurcation of the tree, and a hemidisc was detected trapped at the level of the 1st bifurcation of the left inferior pulmonary vein. The valve part was completely pulled out using forceps (Figure 2). Deaeration and suturing of the vein were performed (Figure 3). The patient was successfully weaned from bypass. The postoperative course was uneventful, and the patient was discharged from the hospital on the 6th postoperative day.

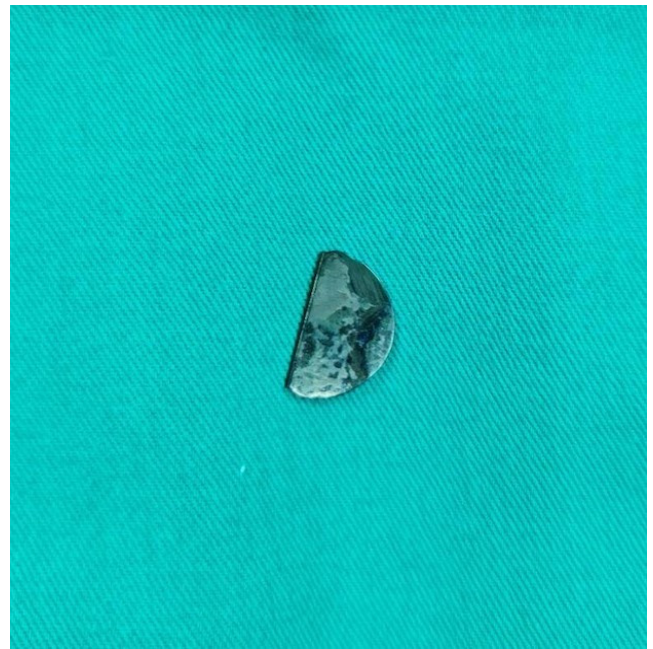
Fig. 2 - Extracted mechanical valve hemidisc.

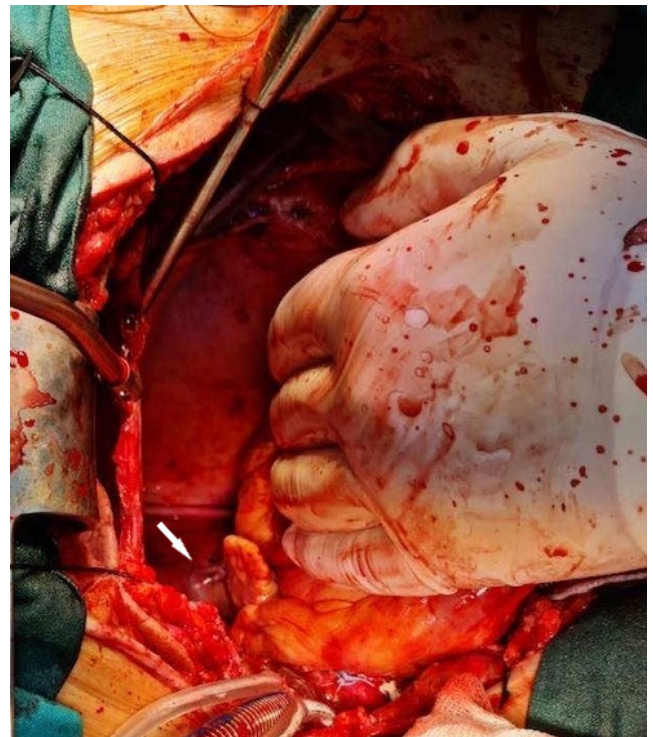
Fig. 3 - Surgical view of the sutured left inferior pulmonary vein. White arrow = left inferior pulmonary vein
